Evaluation of Buried Secondary Containment Liners

Steven L. Anderson, P.E.¹, Alexandre Lai, P.E.², and Rupert “Bucky” Tart, Jr., P.E.³

Abstract

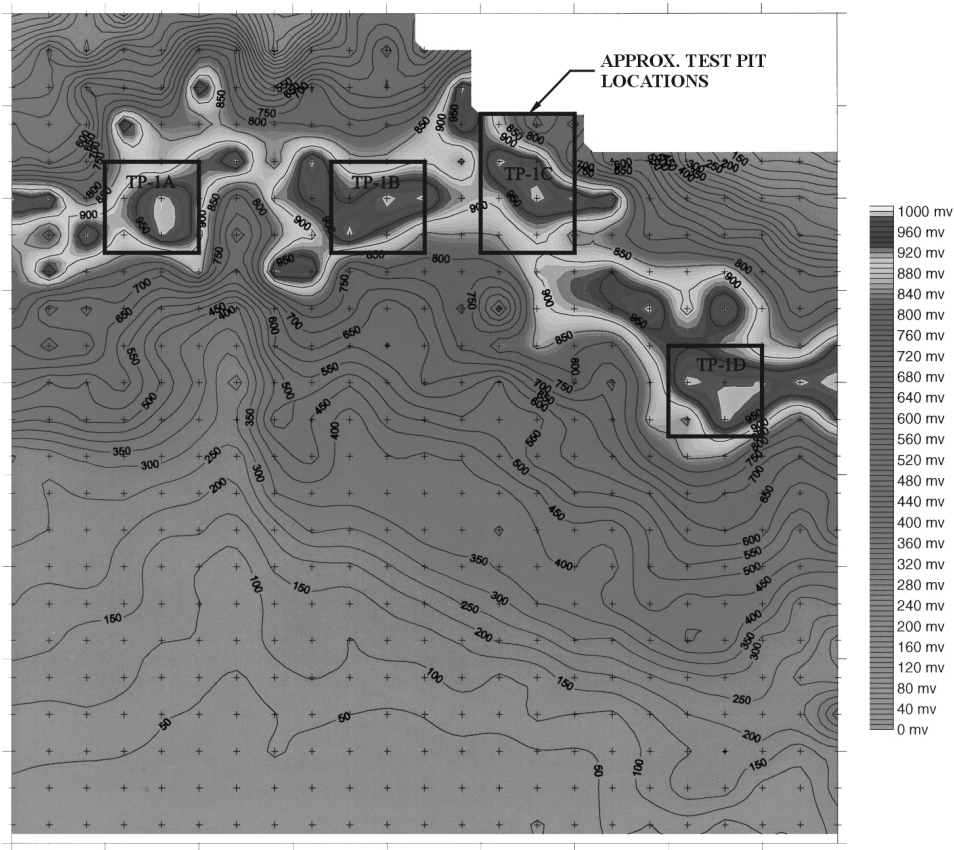
Figure 1. ELD Survey Results for Trench 1 at Pump Station 5

An example of the contour plan of current potential data developed during the ELD survey and the approximate location of the test pits is shown in Figure 1. The anomalies were identified as those with readings larger than 950 mV at Trench 1, larger than 150 mV at Trench 2, and larger than 80 mV and lower than -400 mV at Trench 3. The majority of anomalies were confirmed with test pits.

Based on the results of the excavation program, the ELD was precise and effective at locating leaks in the liner. However, results from the GPR survey were ambiguous and undefined.

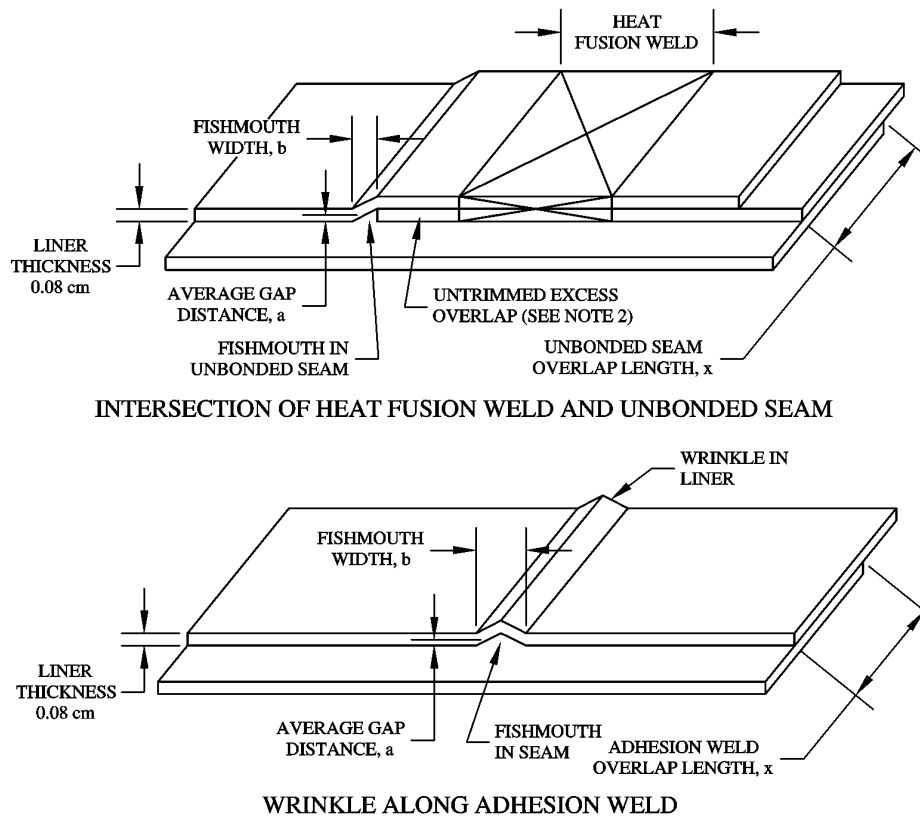
Figure 2. Examples of Liner Seam Fishmouths

The majority of damage observed was caused by perforations that ranged in size from a pinhole (defined in this study as a perforation having a diameter less than or equal to 0.32 cm) to tears up to 2.1 m wide. Seam damage in the form of fishmouths and unbonded seams with less than 5.1 cm overlap were also observed. Sketches of the two types of fishmouths observed are shown in Figure 2.

Figure 2 shows two types of seam fishmouths and the dimensions used to estimate the leakage rate. The average gap distance was estimated from field observations to be equal to the thickness of the liner at a maximum, about 0.08 cm. The fishmouth widths were measured in the field or calculated assuming a 2 horizontal to 1 vertical slope. The seam overlap lengths were measured in the field.

Fishmouths. Fishmouths were discounted because they were observed to be uncommon and have an estimated leakage rate that is very low.

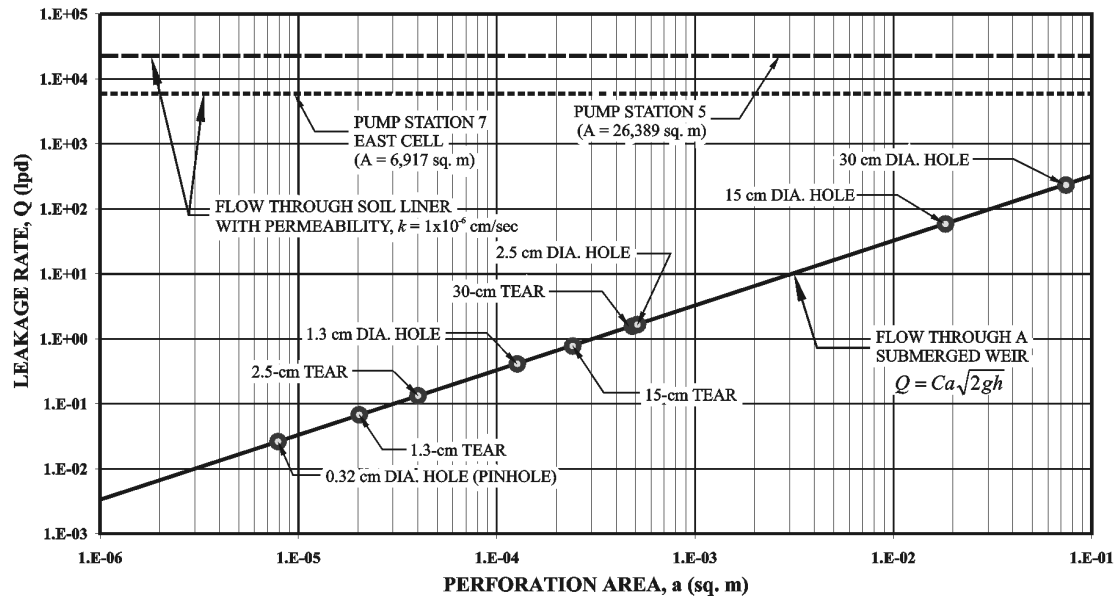
Figure 3. Comparison of Liner Perforation Leakage Rates

A coefficient of 0.6, which is the coefficient for free flow through an orifice (Giroud, et al., 1997), was used in the 1999 Golder study to estimate flow through a geomembrane liner perforation overlain by 61 cm of cover soils that had a permeability of 1×10^{-3} cm/sec. However, calculations using this coefficient overestimated the measured flow rate through a soil cover overlying a geomembrane perforation by four orders of magnitude. Therefore, data from the 1999 Golder study were used to back-calculate a new coefficient value of 8×10^{-6} . This coefficient was then used to calculate the leakage rates for a variety of perforations as shown in Figure 3.

- NOTES: 1. FLOW THROUGH A SUBMERGED WEIR CALCULATED ASSUMING A COEFFICIENT (C) OF 8×10^{-6} AND A HYDRAULIC HEAD (h) OF 1.2 m.
 2. FLOW THROUGH A SOIL LINER BASED ON DARCY'S LAW, $q = kiA$, ASSUMING A HYDRAULIC GRADIENT (i) OF UNITY.
 3. AREA OF TEAR IN LINER ASSUMES WIDTH OF 0.16 cm.

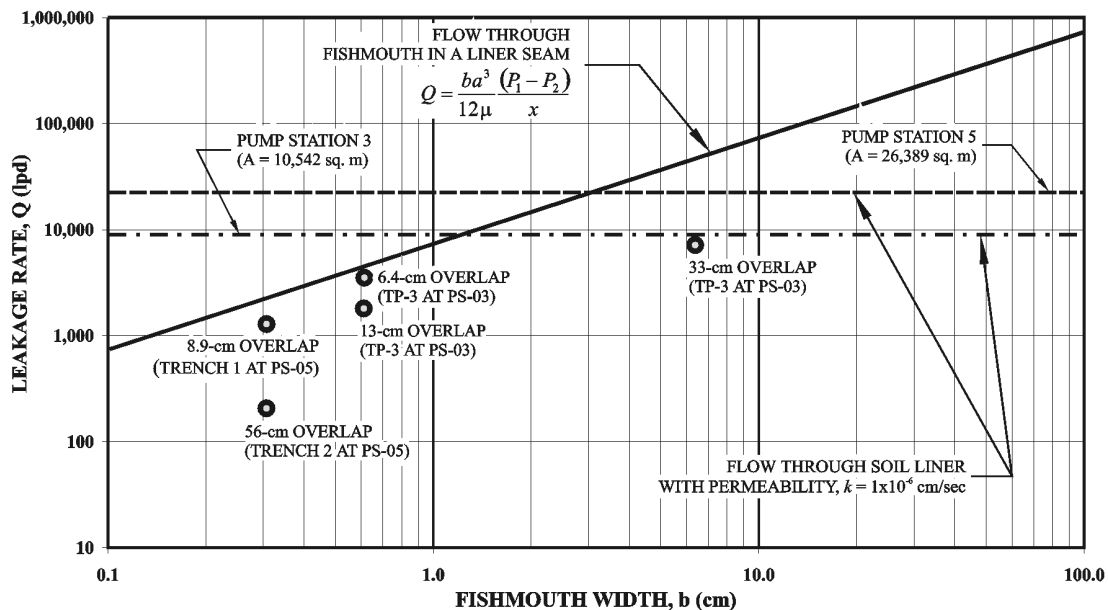
Figure 4. Comparison of Liner Seam Fishmouth Leakage Rates

The calculated leakage rates for the seam fishmouths observed at Pump Stations 3 and 5 are shown in Figure 4. However, since these calculated leakage rates do not consider the reduction of flow due to the cover soils, they are likely to be overly conservative. In addition, based on the previous tests performed by Golder in 1999, the calculated fishmouth leakage rates are also likely to be overly conservative by one to several orders of magnitude.

- NOTES: 1. FLOW THROUGH FISHMOUTH IN A LINER SEAM ANALYZED AS FLOW BETWEEN TWO FIXED PLATES, ASSUMING A 0.08-cm GAP (a), AN ABSOLUTE VISCOSITY (μ) OF 0.001 N-SEC/M², A PRESSURE HEAD AT THE TOP OF THE FISHMOUTH (P_1) OF 1.2 cm, AND A SEAM OVERLAP (x) OF 5.1 cm. CALCULATION DOES NOT CONSIDER REDUCTION OF FLOW DUE TO COVER SOILS.
2. FLOW THROUGH A SOIL LINER BASED ON DARCY'S LAW, $q = kiA$, ASSUMING A HYDRAULIC GRADIENT (i) OF UNITY.
