Performance of the PVR Rock Slope At Valdez Marine Terminal

Graeme Major¹, Rupert G. Tart, Jr.², and Deborah J. Krontz³

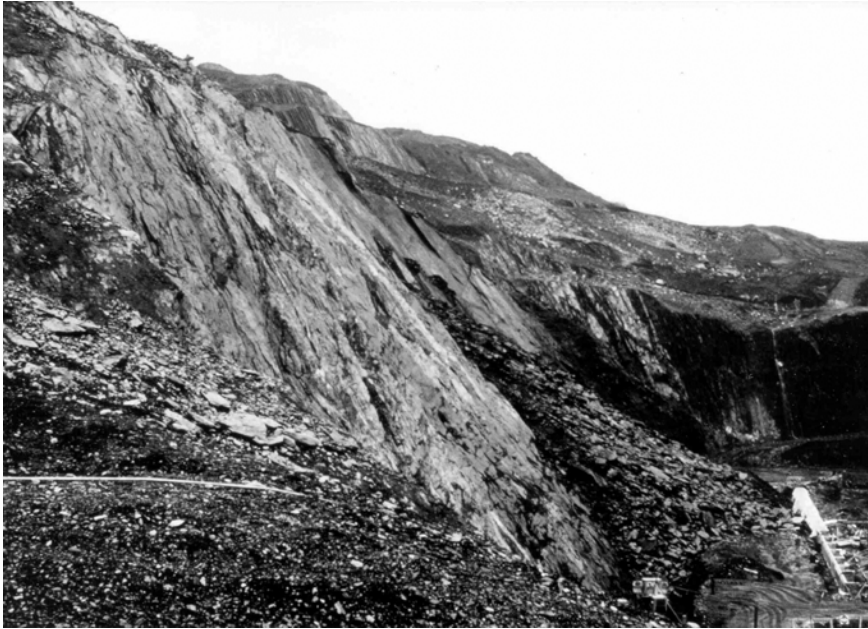
A large failure developed during the initial excavation of the slope in 1975, as shown in Figure 1. The failure occurred largely along foliation planes of the phyllitic bedrock, although it was apparently initiated following exposure of some high-angle, cross-cutting structures near the toe of the excavation. A program of engineering evaluation and design was implemented to mitigate the risks of possible future slope failures. The final slope design included reinforcement of the phyllite slope with 30-foot long, 1-inch, resin anchored, fully grouted, tensioned high strength Dywidag threadbars. Lock-off loads of 60 kips were designed to produce an adequate safety factor against failure for the slope

Figure 1. Failure of the PVR Slope in 1976

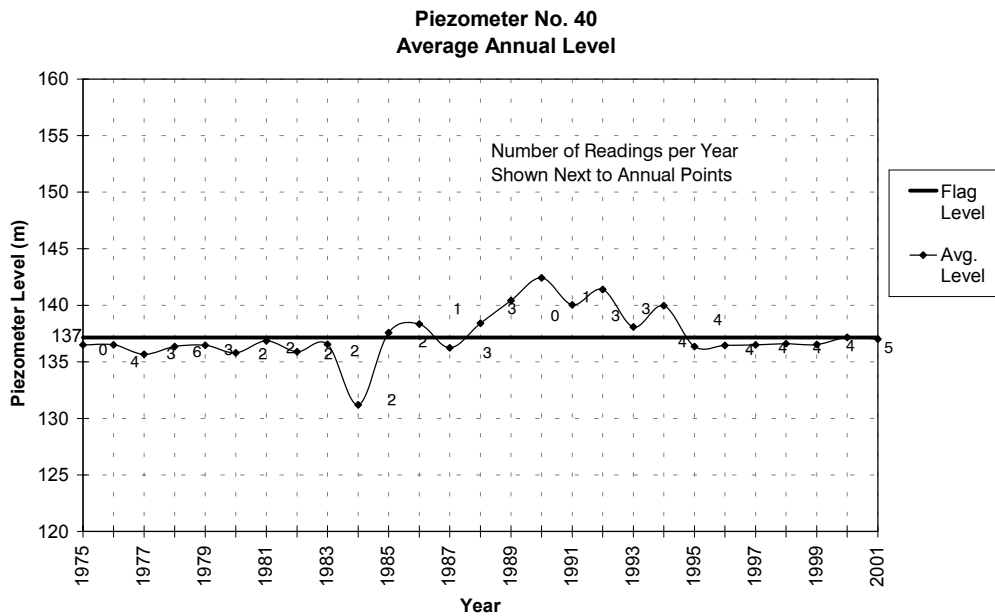
The piezometric level at Piezometer 47 was always close to the flag level from the time of installation, but appears to have risen by approximately eight to ten feet in the more than 20 years since construction. The piezometric level at Piezometers 40, 49, and 50 were also always close to the flag level, and have risen approximately two to six feet since construction. These excursions are only local phenomena of limited magnitudes; the average piezometric levels throughout the slope are well below the flag and design levels as shown in Table 1. The slope is therefore considered to be in general compliance with the design-basis groundwater assumptions.

Figure 4. Average Annual Water Level at Piezometer 40

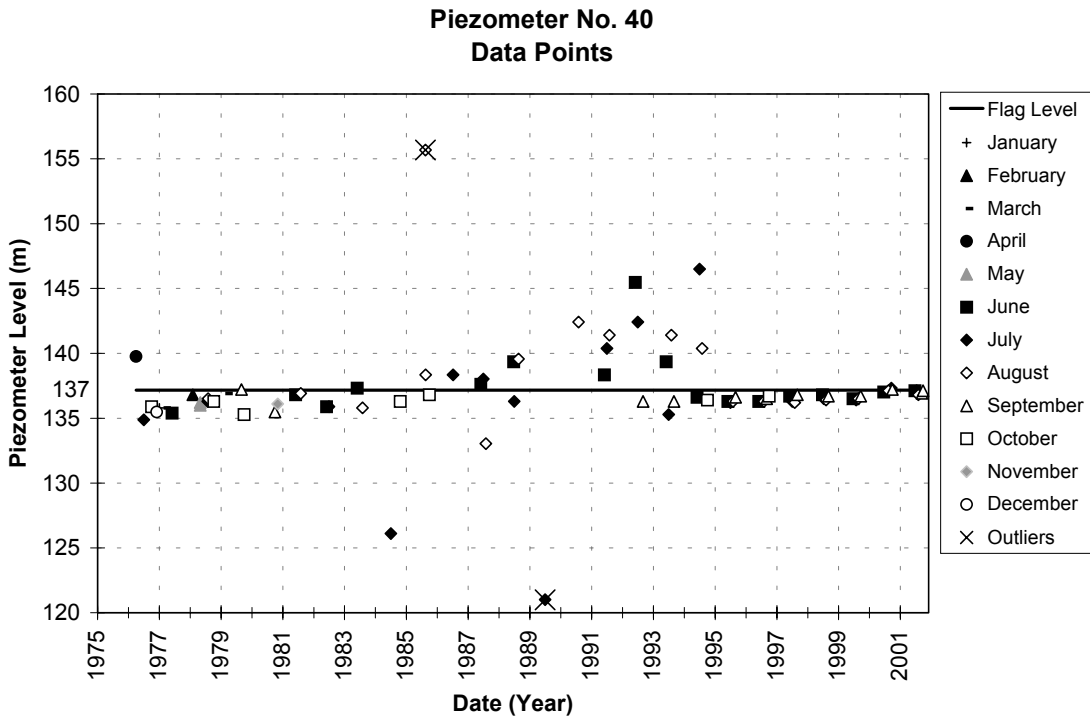
Figure 5. Monthly Water Levels at Piezometer 40
