Performance of The Squirrel Creek Slopes Steep Slopes on Discontinuous Permafrost

Rupert G. Tart, Jr.¹ and John E. Ferrell²

Abstract

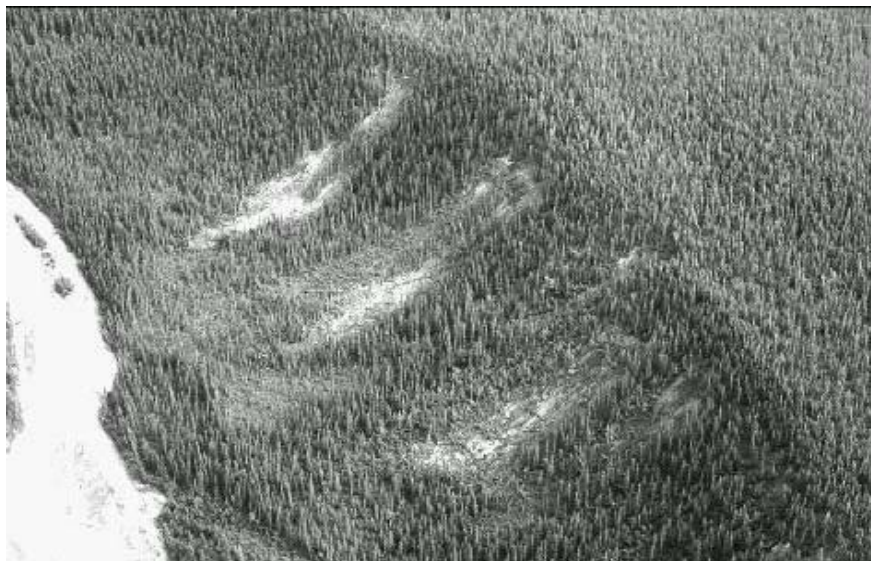
Figure 2. Natural Slides in Squirrel Creek Area

In the Copper River Basin, the pipe crosses several east-west trending drainages that direct water from the Chugach Mountains to the Copper River. At pipeline milepost 717, about 83 miles north along the pipeline from Valdez, the pipeline crosses Squirrel Creek as shown in Figure 1. Both the north and south approaches to Squirrel Creek were steep and presented concerns to the pipeline designers. Along Squirrel Creek and other similar drainages in the Copper River Basin, natural landslides were observed on some of the slopes approaching these creeks and rivers as shown in Figure 2.

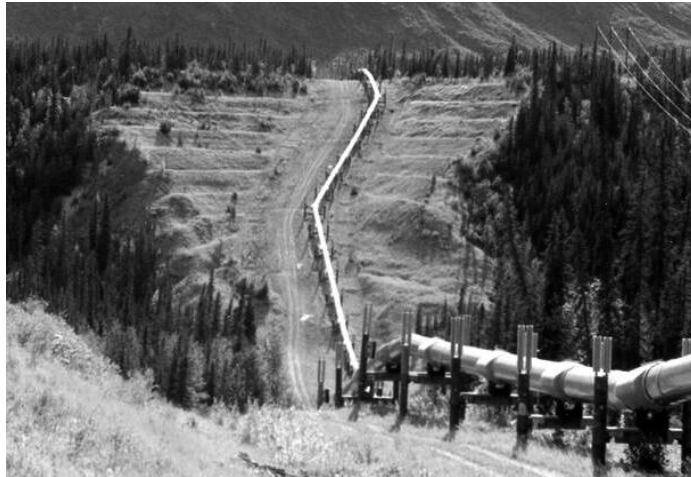
Figure 4. Benches on South Slope

The other design issue was the steepness of the slopes approaching the creek. It was decided to flatten the slopes to no steeper than 27% in the Copper River basin formations. Thus, most of the south approach needed to be cut and a short section of the north slope had to be cut to meet this criteria. The photograph in Figure 4 shows the cut benches on the south approach to Squirrel Creek looking from the short cut section on the north side of the creek.

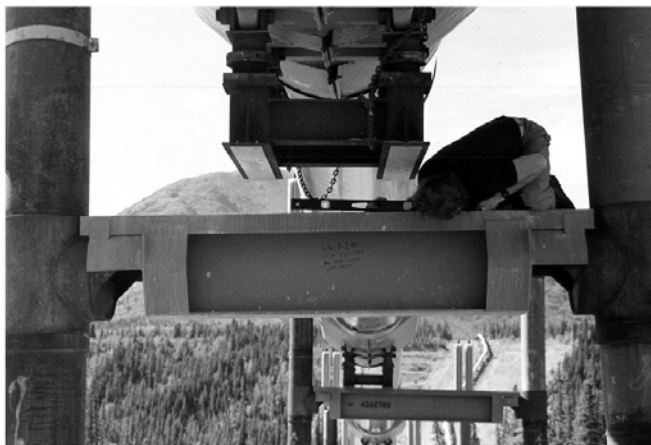
Figure 5. Hanging Shoe

During a slope inspection in 1989, it was noted that one bent had a hanging shoe; the crossbeam had moved down enough that the shoe was no longer being supported as showed in Figure 5. This caused the initiation of a significant research effort by Alyeska. Survey data was studied and modified approaches to the acquisition and reporting of this data were established. A geotechnical drilling program was initiated to determine why the VSM's were apparently settling. The records from infrared surveys of the heat pipes were examined to determine if there had been heat pipe failures.

The bent settled more than one foot before, it was stabilized by adding deep, free-standing heat pipes. The settlement of this bent is inferred in the photograph in Figure 5, which shows the separation of about 0.3 m between the shoe and the crossbeam. At this location, a geotechnical investigation found an ice lens below the bottoms of the VSMs. The ground above the ice lens was thawed although there were significant freeze bulbs still in existence around the VSMs. The continued thawing of this ice lens was halted by installing free-standing heat pipes which extended through the ice zone. It was concluded that the wide zone of vegetation clearing in this area coupled with the fact that this was a south-facing slope, resulted in the development of a deep thaw bulb around the VSMs. The impact of this thawing would not have been as significant if the ice lens had not been under the VSMs. Figure 6 depicts how this thaw bulb likely progressed to the ice lens.

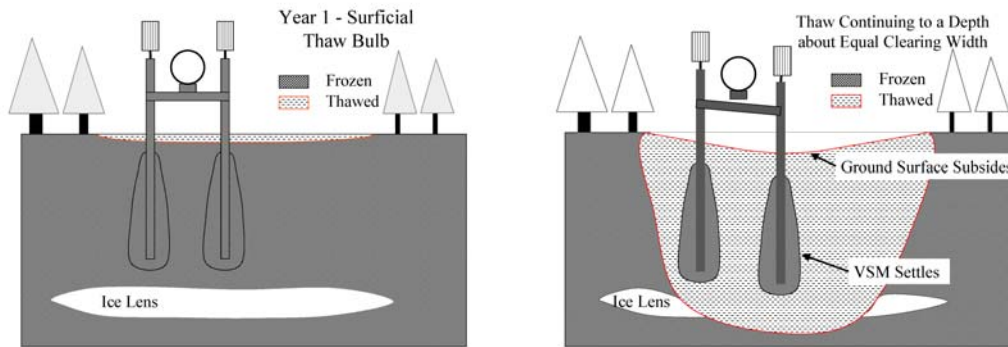
Figure 6. Thawing Around VSMs

Analyses concluded that the clearing of this south facing slope had resulted in the development of a deep thaw bulb around and eventually under the VSMs. The solution was the installation of deep heat pipes near the VSMs to prevent further thaw below the VSMs. After 10 years this solution appears to be working.

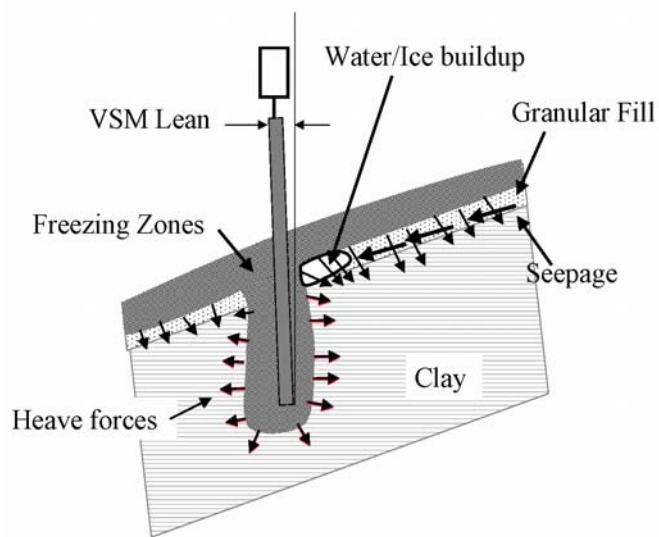
Figure 7. Heaving on a Slope

Another concern developed early at Squirrel Creek. Some shoes were no longer centered on the cross beams and some VSMs were leaning. In addition, wet zones appeared during some periods of the year on the pad and mounding and voids formed around the VSMs. The initial response was to evaluate the impact of these unexpected observations on the integrity of the pipeline system. In some cases the contact between the shoe and beam was not uniform or only one skid of the shoe was touching the beam. In Figure 7, the heave process is depicted as VSM heave is beginning to initiate in mid-winter. There is a frozen bulb around the VSM and the frozen active layer has connected with the frozen bulb. The freeze front has not reached the bottom of the permeable workpad. Water is perched on the low permeability silts and clays under the workpad. It continues to flow downslope being trapped by the freeze fronts from the active layer and the frozen bulb around the VSM. The greater availability of water upslope of the VSM results in downslope, lateral heaving as the water freezes and there is more expansion at the upslope freeze fronts than at the downslope freeze fronts around the VSM. The VSM heaves and leans downslope as shown in Figure 8.

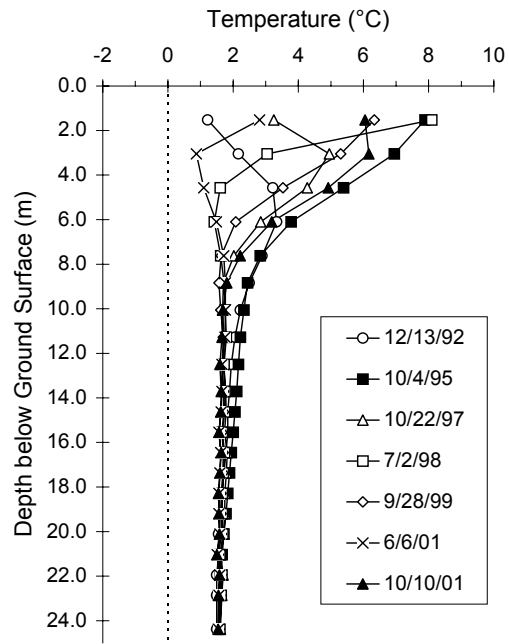
Figure 9. Long Term Temperature Results

The thermistor strings have shown some slight warming, but no significant areas of thermal state change. Figure 9 shows typical results from a thawed area on the south approach. Since their installation, areas that were thawed have remained thawed and areas that were frozen have remained frozen. The major changes have been in the active layer, as one would expect. The active layer freezes each fall trapping near surface groundwater flowing over the slope as shown in Figure 7. As the active layer freezes, it begins to heave the VSMs, as shown in Figure 7. The trapped water flows to the freeze front resulting in more heave as the front progresses downward. Because the heave is occurring on a slope, the VSMs lean downslope as they heave. Also, as the trapped groundwater freezes in the gravelly workpad capping the slope, it loosens this fill.

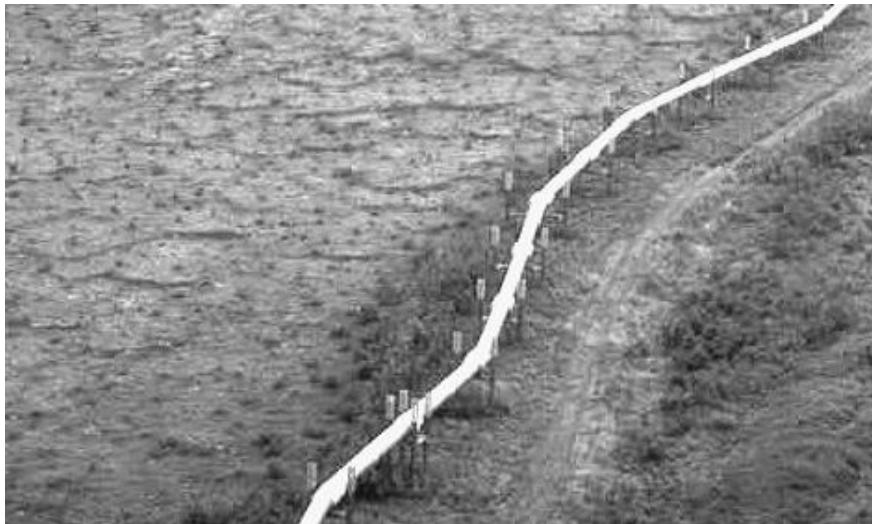
Figure 10. Solifluction Lobes Along TAPS

When thaw begins at the ground surface the loosen gravel fill becomes soft and wet until it has time to settle and drain. While it is wet and loose it sometimes can have near surface downslope movements similar to the solifluction movements seen in permafrost terrain such as the area shown in Figure 10. Mounds are created around the VSMs as shown in Figures 11 and 12. In some places the thawing results in springs and pipes as the frozen layer becomes thin enough to release the trapped groundwater. See Figure 13.

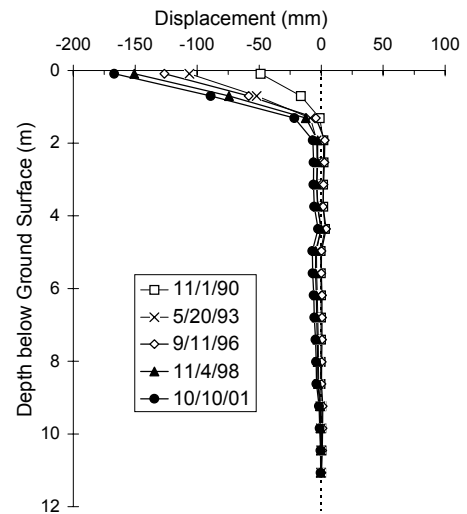
Figure 14. Skin Friction Displacements

The inclinometers confirm that the only movement on the south side of Squirrel Creek is the solifluction of the active layer. An example of this movement as depicted by plotting the slope indicator data is presented in Figure 14. At other bents on these slopes the inclinometers have shown limited zones of downslope movements resulting from deep thawing and movements away from growing freeze bulbs.

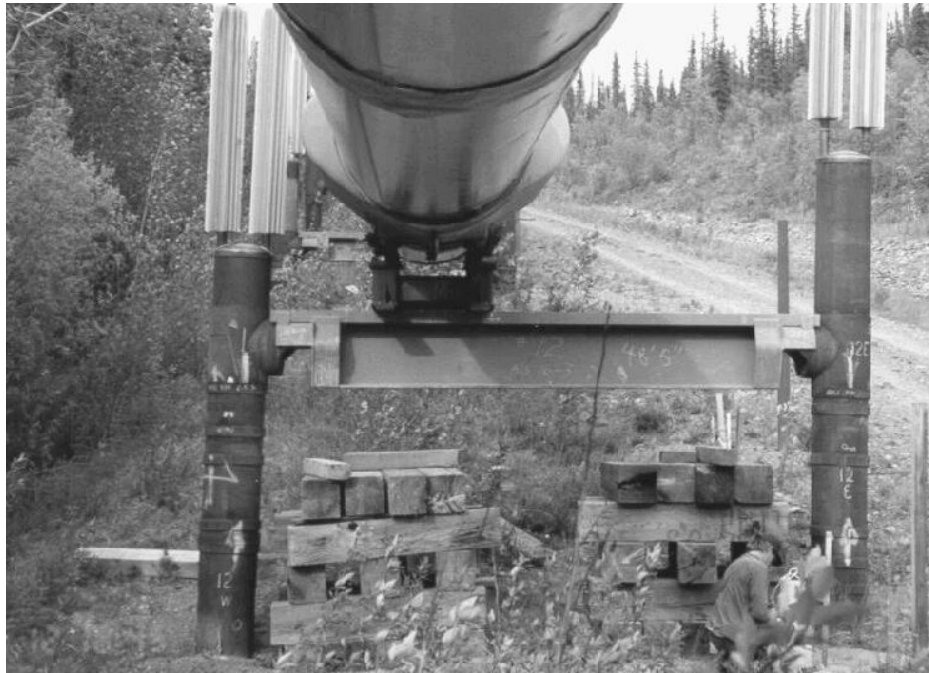
Figure 15. VSMs That Have Settled

The liquefaction criteria used by the designers concluded that saturated granular formations that had been recently frozen became liquefiable upon thawing. Thus, some of the area immediately adjacent to Squirrel Creek would be considered liquefiable when these areas thawed. Bent 12 located about 200 m north of Squirrel Creek falls into this classification.

Prior to these adjustments, adjacent bents did not settle significantly, but maintained the pipe support taking the increased loads which resulted from the loss of support at Bent 12. Considering this, and gravelly nature of the formation, it has been concluded that there was likely an ice pocket near Bent 12 which probably thawed and resulted in the movement at that bent. As shown in Figure 16, the other adjacent bents not moved nearly as much as Bent 12. Areas of large movement usually indicate areas of settlement or heave. Small movement zones are indicative of stable VSMs.

To stop the settlement of Bent 12, the VSMs were pushed into the ground by statically loading the bent. Steel split rings are welded to each VSM to provide support point for the crossbeam. The split rings were raised until the load of the pipe and shoe were being supported on the crossbeam. As the VSMs settled more, the split rings were adjusted again until the pipe was being supported. When the VSMs had settled about 4 to 6 ft they began to have sufficient resistance to provide support to the pipe as shown in Figure 15. Alyeska continues to monitor this bent and will adjust the split rings to maintain load on the VSMs in the future, if necessary.
