Assessment, Design, and Some Lessons Learned From Application of Natural Channel Design Principles in Conversion of a Multiple Thread to Single Thread Channel on an Alluvial Fan

Abstract

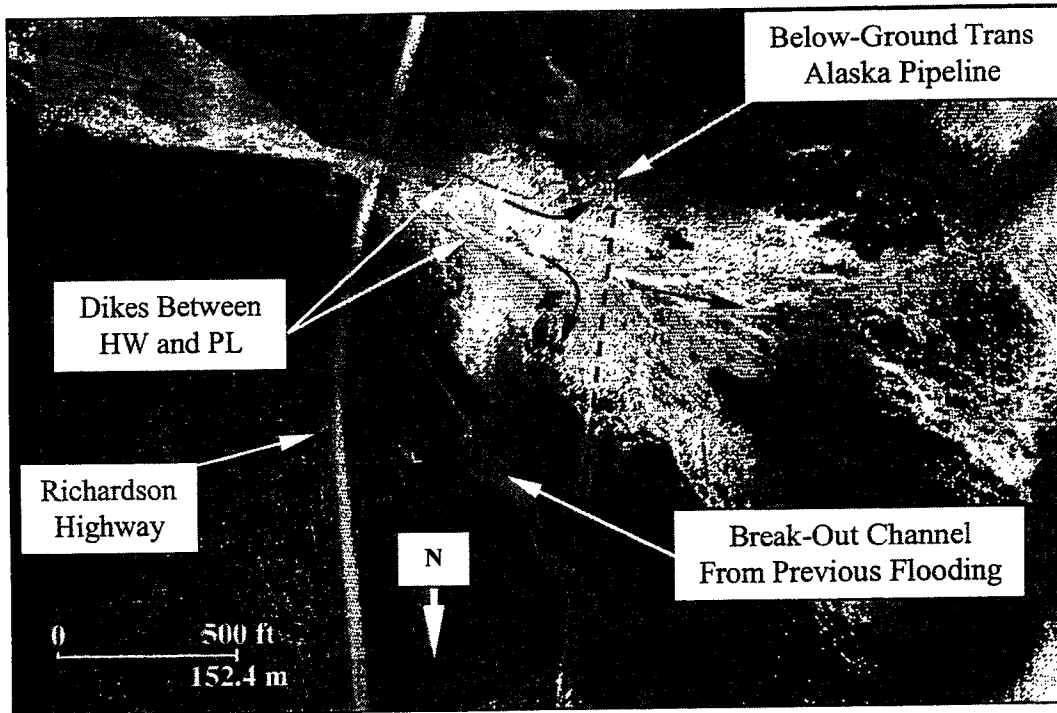
Figure 2. McCallum Creek Prior to Channel Conversion

McCallum Creek flows westward across the Richardson Highway and Trans Alaska Pipeline (TAPS) about 30 km (18 mi) north of Paxson in the Central Alaska Range. The Richardson Highway Bridge is approximately 220 m (725 ft) upstream from the pipeline crossing. McCallum Creek joins Phelan Creek about 0.8 km (0.5 mi) downstream from the pipeline crossing. The reach between the Highway Bridge and Phelan Creek crosses a broad alluvial fan with a down valley gradient of approximately 1.5 percent. This reach has historically been a braided channel relatively free of riparian vegetation, Figure 2.

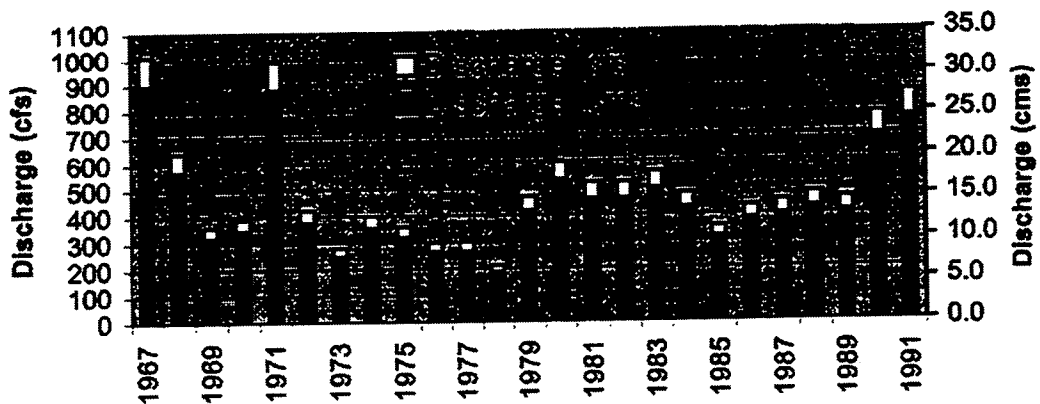
**McCallum Creek Annual Peak Flow
1967 to 1991**

Figure 4. Peak Flow Histogram, USGS McCallum Creek Gage

Glacial melt, snowmelt, and rainfall runoff influence the flow regime at McCallum Creek. Spring snowmelt runoff and summer glacial melt provide sustained but low to moderate flows. Large flood events are associated with rainfall runoff or a combination of rainfall runoff and snowmelt. The Richardson Highway Bridge at McCallum Creek was the site of a US Geological Survey (USGS) crest-stage gage from 1967 to 1991. An initial approximation of the bankfull discharge was estimated from the 1.5-year flood (Log Pearson III), at 11.3 cubic meters per second (cms) (400 cubic feet per second (cfs)), Figure 4. The maximum known flood was on August 13, 1967 at a discharge of 28.6 cms (1010 cfs) (Jones and Fahl, 1994). The 1967 flood was a regional event that caused major flooding throughout the Tanana River basin. The USGS maintains a long-term daily gage near the terminus of the Gulkana glacier on Phelan Creek, about 9 km (5 mi) from the study site.

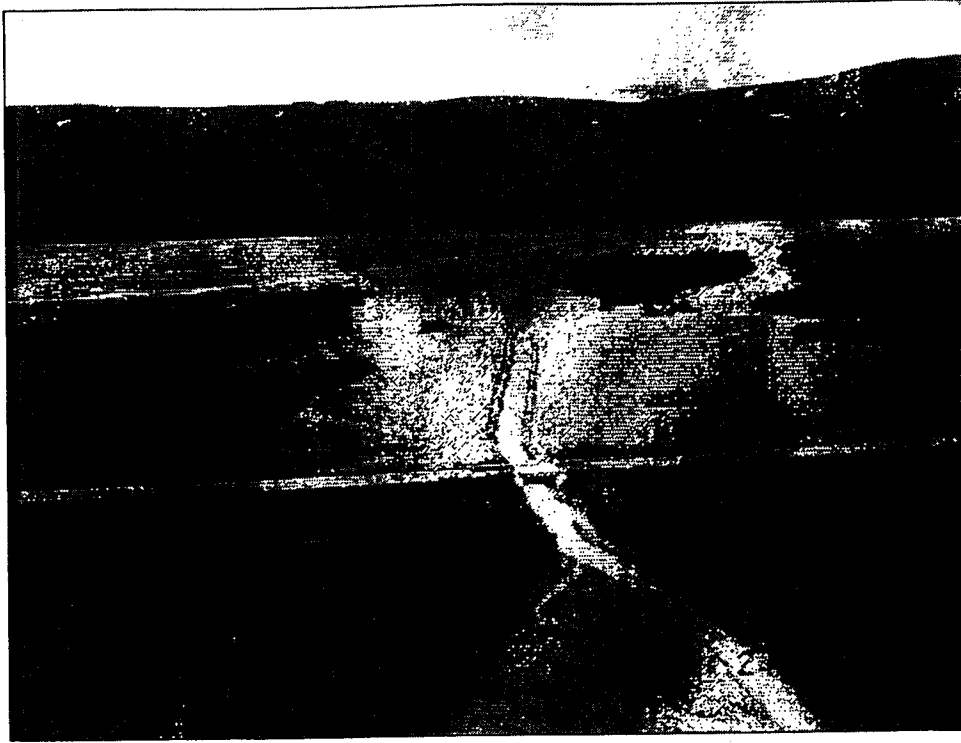
Figure 6. McCallum Creek Following Channel Conversion

Objectives included controlling the position of the creek at the pipeline crossing; protecting fish passage and fish habitat at the site; and minimizing, to the extent possible, aufeis accumulations at the reach. The design concept involved converting the braided channel to a stable single thread channel between the highway-bridge and pipeline crossing, Figure 6.
