TRANS ALASKA PIPELINE SYSTEM | the facts.

Trans Alaska Pipeline System

A collection of facts compiled over the duration of the operation of the Trans Alaska Pipeline System, by Alyeska Pipeline Service Company.

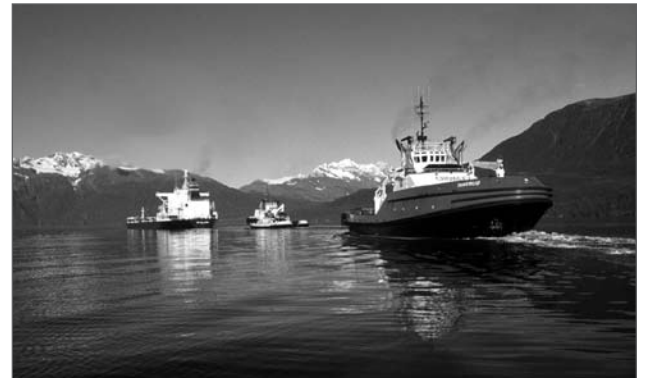
The *Tan'erliq* (far right), one of two enhanced tractor tugs at the Valdez Marine Terminal.

**ENHANCED TRACTOR TUGS (ETT):** *Nanuq* and *Tan'erliq* (Alaska Native words for "polar bear" and "black bear"). Designed for tethered tanker escort and oil spill response operations. The 153-foot vessels enhance SERVS' ability to assist a disabled tanker. The state-of-the-art vessels have exceptional maneuverability and were deployed in 1999.

- Crew: Seven trained response personnel.
- Firefighting: ABS Class 1 firefighting rating that includes pumps, monitors, foam and vessel spray system.
- Propulsion: Voith Schneider system; 10,192 hp.
- Spill response equipment:
  - 3,300 feet of oil containment boom.
  - DESMI skimmers.
  - 70,000 gallons of recovered oil storage capacity.
  - Dispersant spray arm systems.

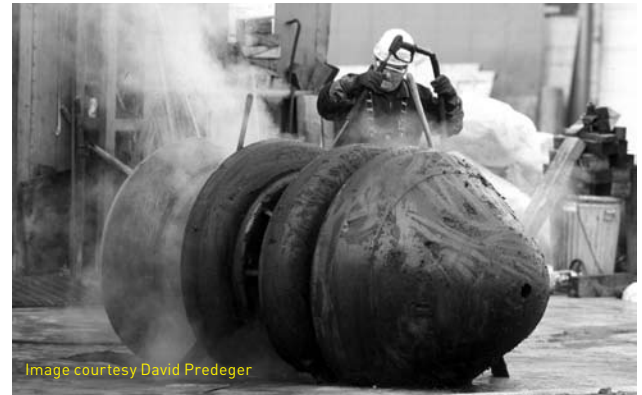
A TAPS employee cleans a scraper pig at the Valdez Marine Terminal. Scraper pigs, which clean the pipeline and enhance oil flow, are pushed by the oil.

- **Cleaning pig:** Also known as scraper pigs, these pigs sweep the pipe of built up wax, water or other solids that precipitate out of the oil stream. They prevent the buildup of a corrosive environment. Their use also makes the oil easier to pump.

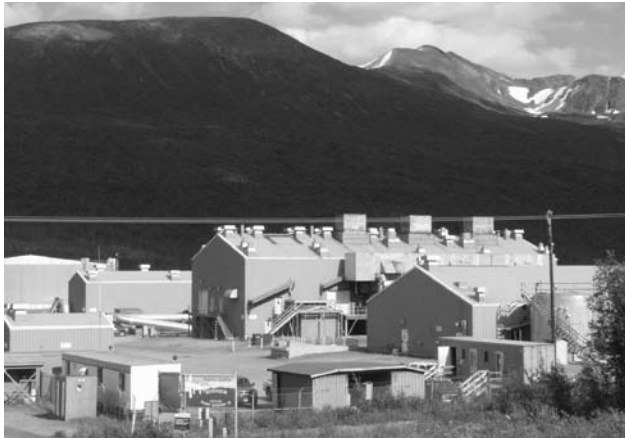
Pump Station 12, 65 miles north of Valdez, is the southernmost station.
